Inspection Bulletin

North American Standard Inspection Program

2018-02 – Motorcoach Monocoque Frame/ Suspension Inspections

Created: April 12, 2018

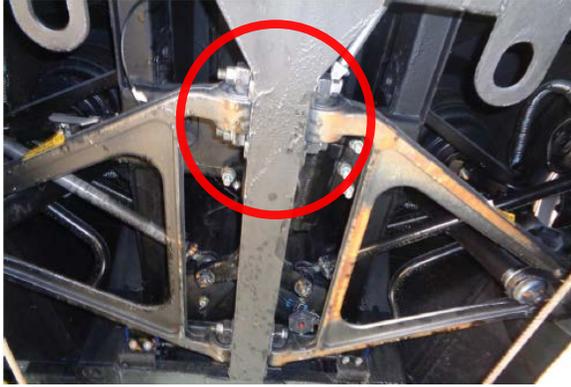
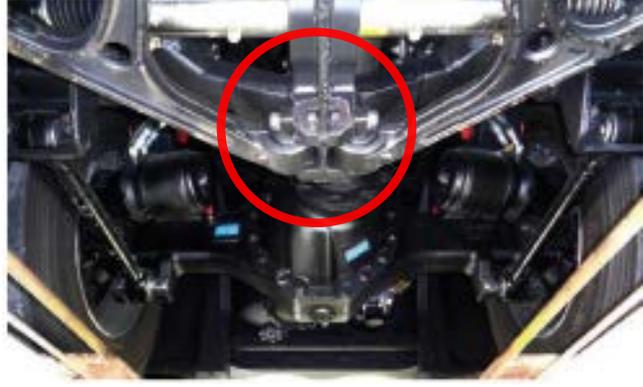
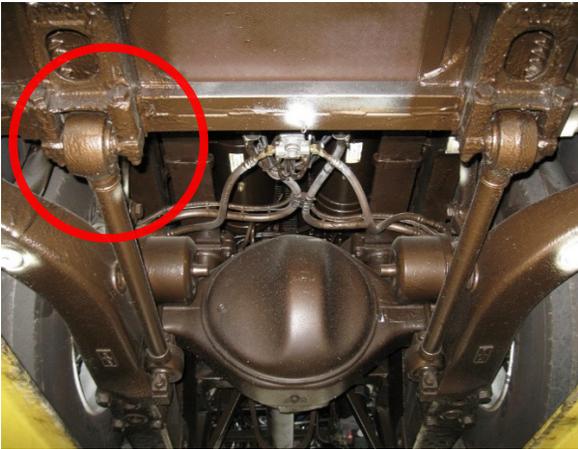
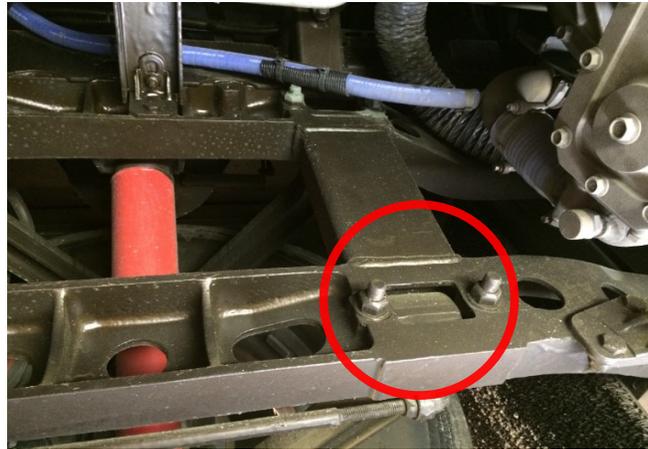
Below are examples of motorcoach monocoque frame and axle support areas that may be seen during inspections.
