Commercial Vehicle Safety Alliance

I N S P E C T I O N B U L L E T I N

2007-01

Express Brake International, Inc. – Segmented Brake Linings

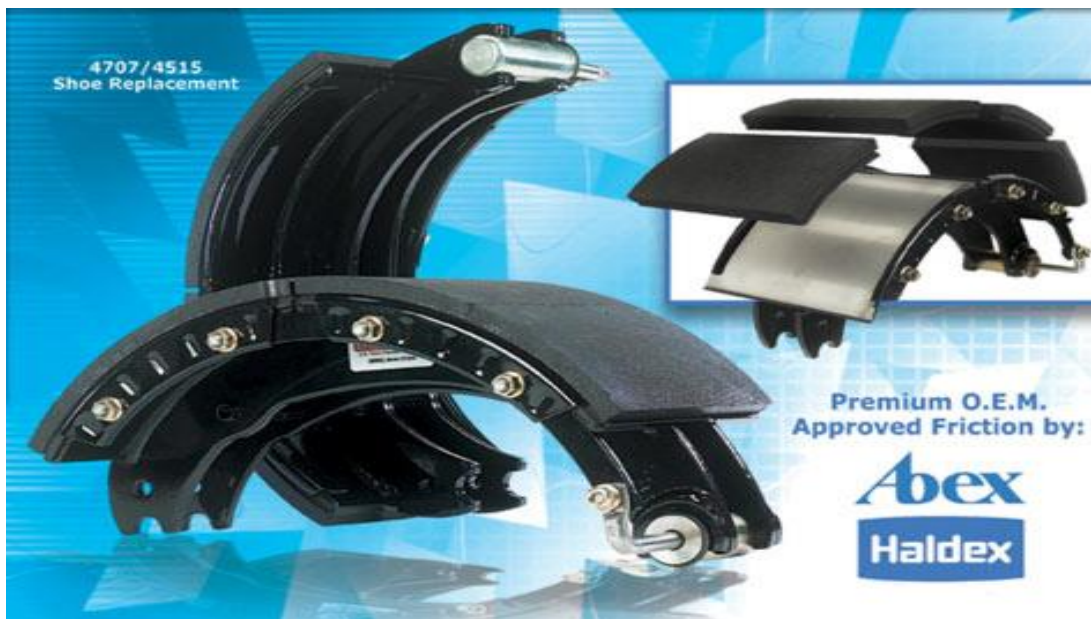
The brake system uses segmented linings that are mounted to a stainless steel brake table that has full seam welded webs with hardened ends and stainless steel lining retainers in lieu of rivets or bonding. The linings are machined with tapered grooves on both the inner and outer edges and designed such that the retainers pull them tight onto the brake table as they are tightened.

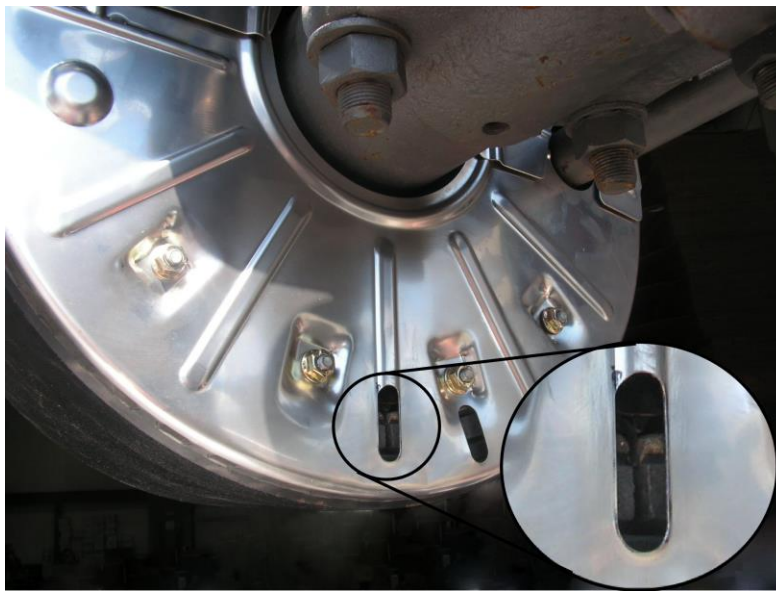
Figure 3 – Express Brake Dust Shields

Express Brake Dust Covers may be used with Express Brake shoes. These dust shields are constructed of 304 grade stainless steel and mount directly onto the brake shoes using four (4) fasteners (see Figure 3). This attachment system is unique to Express Brake and can be easily identified.

Brake lining inspection is performed visually by inspecting linings using the upper or lower view ports installed at the 6 or 12 o'clock positions in the dust covers. Through these ports, lining thickness can be verified.
