## 2012-02 – Brake Pedal (Valve and Treadle Assembly) Inspections

This Inspection Bulletin describes inspection procedures for the brake pedal (valve and treadle assembly) on air-brake equipped vehicles.

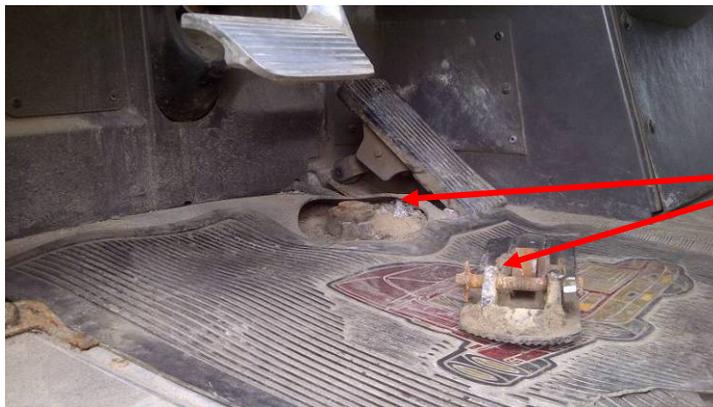
Broken Mounting Plate  
Ear/Pivot Support

**Figure 1: A detached brake treadle illustrates a potential result of excessive corrosion damage.**

In many vehicles, the brake valve and treadle (pedal) assembly is mounted to the cab floor where it is subject to abrasive dirt and sand, as well as corrosive chemicals such as road salt and water. As a result, a small amount of corrosion in the metal parts of the assembly is normal (such as light rust or oxidization). However, as vehicles age, the corrosion can cause pitting or reduction of component material, heavy rusting, etc., and can develop into operating or mechanical problems that can lead to brake malfunction, damage and/or failure, as seen in Figure 1.

The mounting plate ears/pivot supports can become damaged from corrosion and eventually even fail. When the mounting plate ear/pivot support on one side has broken off, the treadle can operate somewhat normally. When both mounting plate ears/pivot supports break, the treadle will detach from the mounting plate and valve. These conditions can be identified with a visual inspection.

1. With brakes released, visually check the condition of the mounting plate ears/pivot supports of the valve and treadle assembly for cracks or damage.

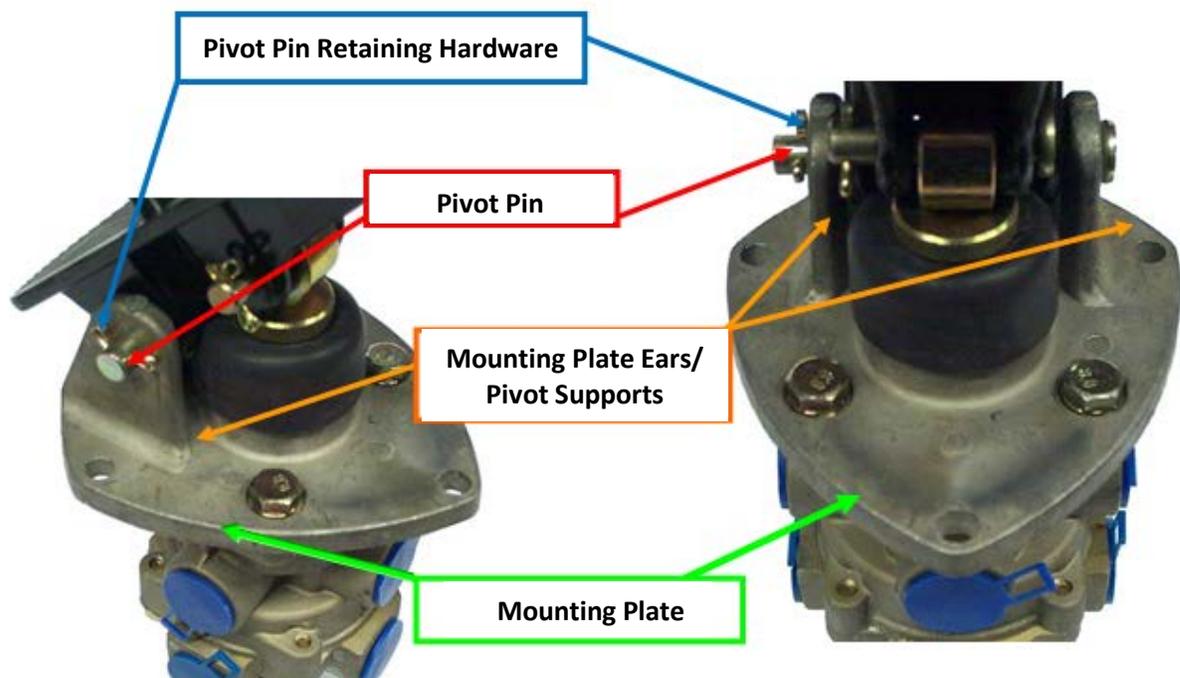
Below are images of an air brake foot valve and treadle assembly with a mounting plate in new condition showing the pivot pin, mounting plate ears/ pivot supports, pin retaining hardware and mounting plate locations.
