2018-03 – Doleco USA Textile Link Tiedown Assembly

Summary

This Inspection Bulletin provides guidance for identifying and inspecting the Doleco USA textile link tiedown assembly (used for cargo securement on trucks or trailers) during a roadside inspection. It also provides guidance for identifying when a defect found within the system qualifies as a violation or an out-of-service condition.

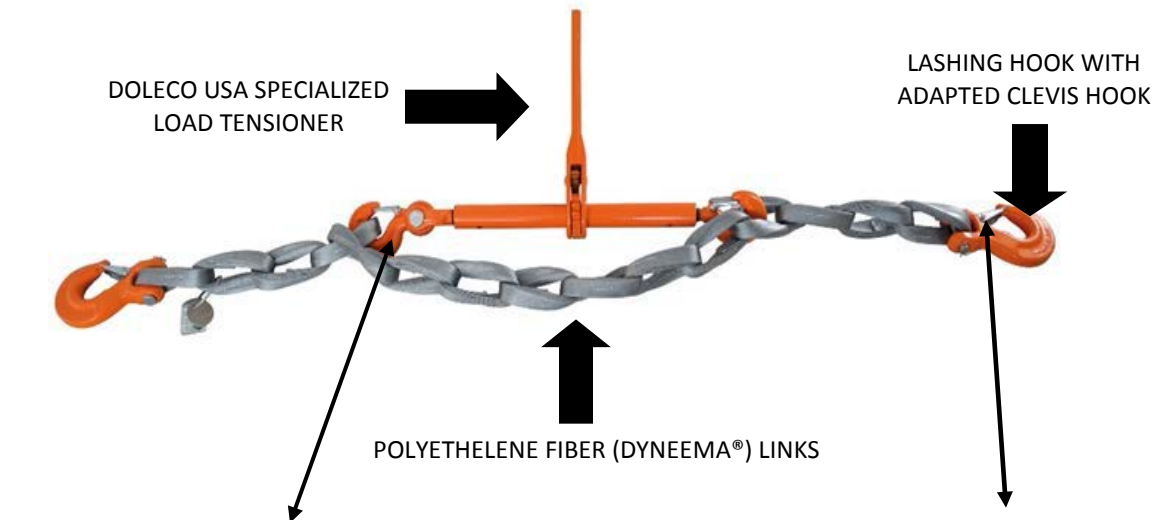
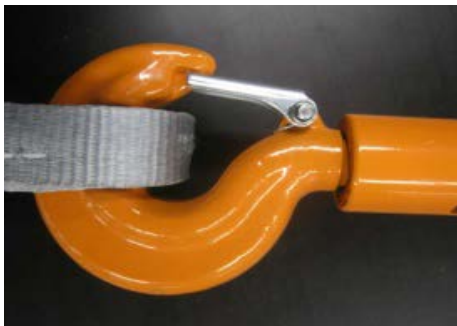
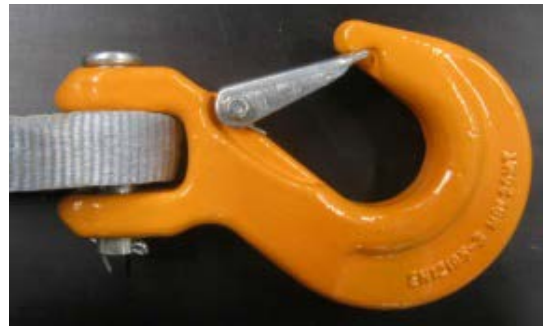
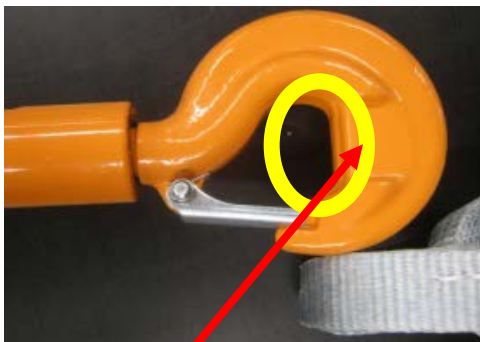
Linked Webbing System Components and Nomenclature

WIDENED HOOK SUPPORT

The Doleco USA lashing tiedown may only be tensioned and shortened using the Doleco USA special load tensioner Grade 100 (WLL 22,000 lbs. (9,979 kg)) with a specially developed widened hook support. The lashing hook with the adapted clevis hook mount has likewise been developed for the special shape of the textile link. Other fittings may not be used. The tiedown assembly can only attain the manufacturer's WLL if all the components are used together. (NOTE: Utilizing the lashing in a choker hitch – as shown on this page – reduces the WLL by 20 percent)

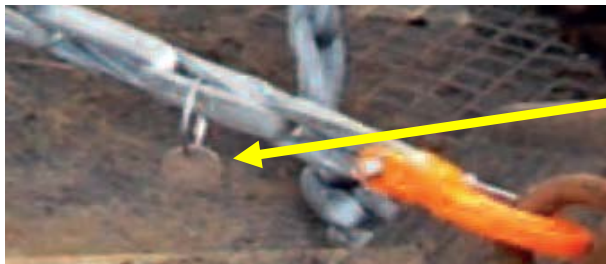
The WLL of 22,000 lbs. (9,979 kg) for the tiedown assembly is marked by the manufacturer with a metal tag attached by a small cable to the assembly. The tiedown assembly will be afforded this WLL provided the tag is present.

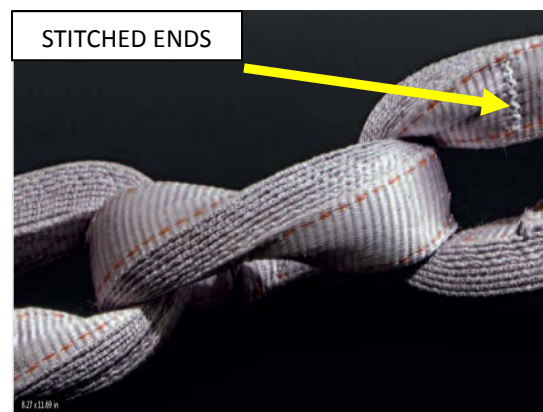
The links are made by weaving narrow polyethelene (Dyneema®) fibers, stacking the resulting fabrics into eight-layer links and stitching the end connections with Dyneema® yarn. Each link contains a half twist and therefore has no real inner or outer side. This results in an even loading of the layers. The performance of such a shaped winding link is considerably higher than that of similar multi-layer winding where the layers are simply placed above one another.

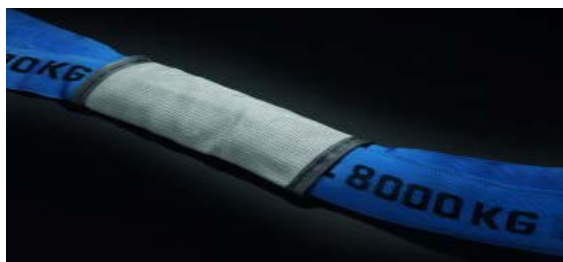
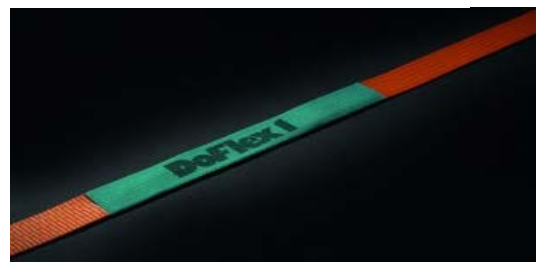
MANUFACTURER-PRODUCED EDGE PROTECTION

As per the manufacturer, the textile links may only be used with loads containing sharp edges and rough surfaces if the endangered points are protected (e.g., the DoAntiCut® protective sleeve made of UHMW-PE).

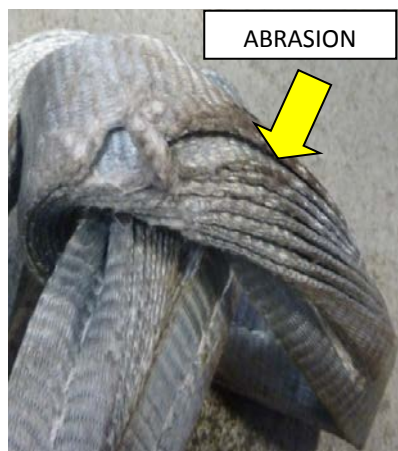
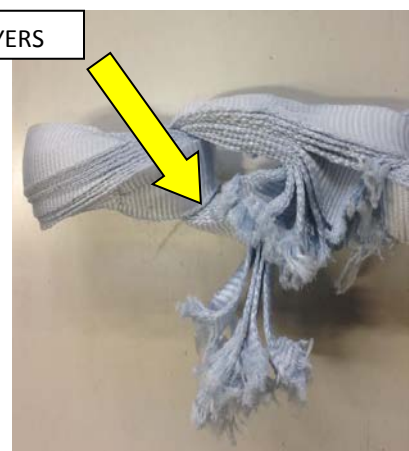
- Tiedowns shall not be loose.
- Tiedowns must not be knotted.
- A fitting, tensioning device or other hardware (other than webbing) shall not be broken, obviously sprung, bent, twisted, or contain a visible crack, significant nick or gouge.
- Tensioning and connecting elements must not be loaded to the point of bending.
- Links shall not be deformed due to heat (friction, radiation).
- Lashing hooks must be loaded in the hook bowl (see lashing hook with the adapted clevis hook mount). Links may not be loaded on a hook tip.
- The hook mouth must not be widened by 5 percent or more.
- Links shall not contain cut layers and severe abrasions.

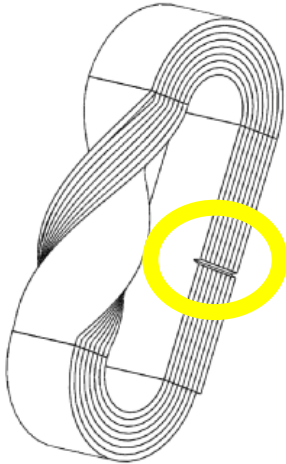
TRANSVERSE

- Links shall not have more than one 10 percent transverse or longitudinal cut.

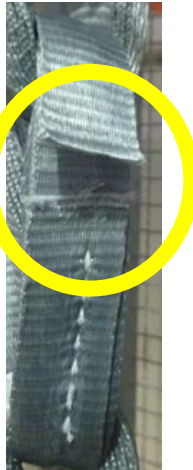
- Links shall not have one ply (or more) cut through - inside or outside.

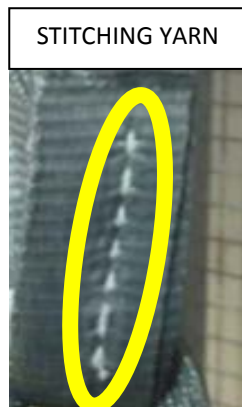
- Links must have yarn completely through the stitching; not partly cut through.

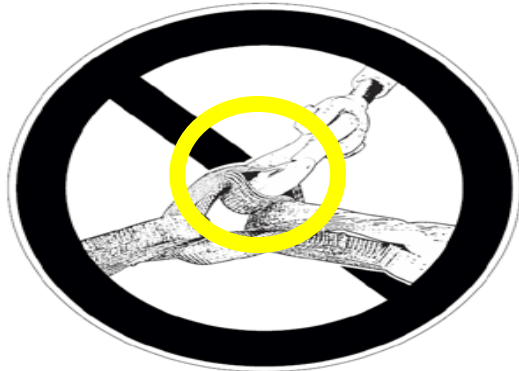
- The hook shall not be hooked in between the plies.

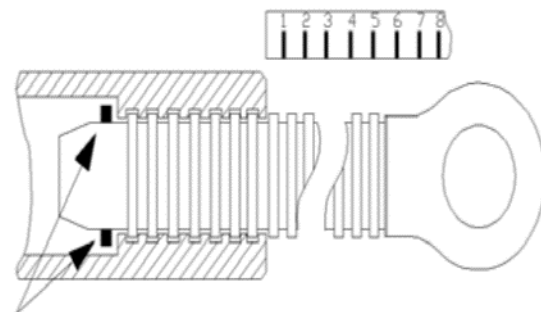
Safeguard

The special load tensioner is equipped with an unscrewing safeguard.

The unscrewing safeguard of this tensioner consists of a bolt at the end of the spindle arm that stops against the internal thread of the guide tube as soon as the maximum unscrewing length has been reached. Overturning of this safeguard is possible only with the use of extreme force and is noticeable in all cases. If the safeguard is overturned, the bolt cuts into the internal thread of the guide tube and destroys it.
