**Pipeline and Hazardous
Materials Safety
Administration**

Reference No. 24-0043

This letter is in response to your May 29, 2024, email requesting clarification of the Hazardous Materials Regulations (HMR; 49 CFR Parts 171-180) applicable to the “emergency shutoff” marking on cargo tanks. You provided photographs of a cargo tank motor vehicle (CTMV) that has two markings in separate locations. The primary marking is located directly beside the manually-activated remote shutoff device on the rear-end tank protection device, but the marking is damaged. The secondary marking is located on the right rear side of the cargo tank, pointing vertically downward in a manner you believe is in an area immediately adjacent to the manually-activated remote shutoff device. You also note a previous letter of interpretation (Reference No. 17-0029), which you believe represents your current situation regarding the placement of the secondary “emergency shutoff” marking on the cargo tank. Acknowledging that the primary marking is weathered and damaged such that it does not satisfy the marking requirement, you ask whether the secondary marking satisfies the requirement of § 172.328(d) to have an “eme

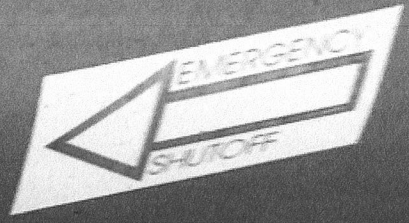
T279

One of our drivers received a violation in Colorado today because the inspector thought the Emergency Shutoff decal on the left front of the cargo tank should be closer to the actual emergency closure device (a break bolt). Looking at the picture, the decal appears to be about 4 inches to the right of the device and approximately 12 inches above it (see picture in attachment).

EMERGENCY SHUTOFF

Section 172.328(d) does not specify the distance the emergency shutoff marking must be in order to be immediately adjacent to the emergency closure device. However, based on the description you provided in your email and the attached photo, it is the opinion of this Office that the emergency shutoff marking, as pictured, would be considered adjacent to the emergency closure device.

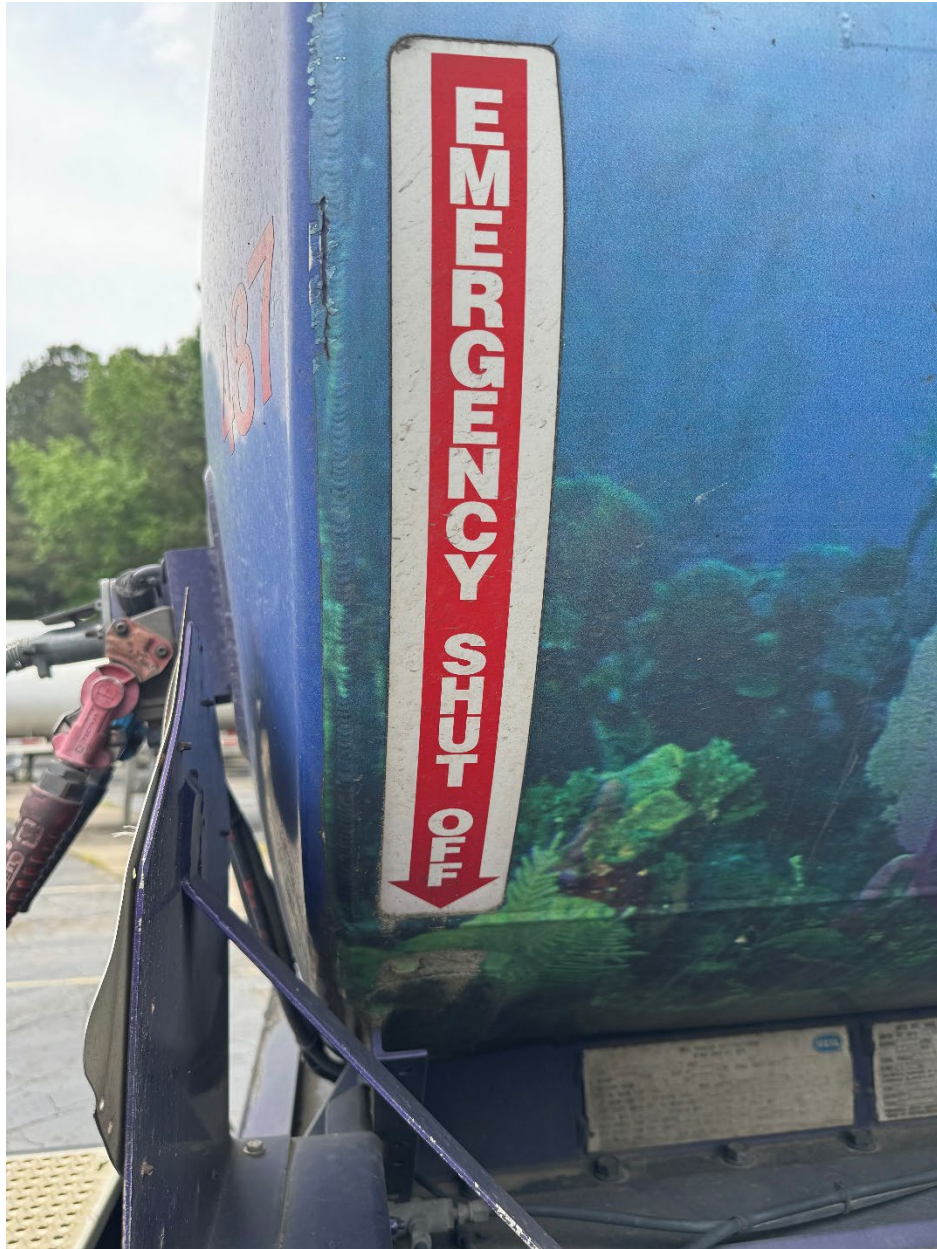
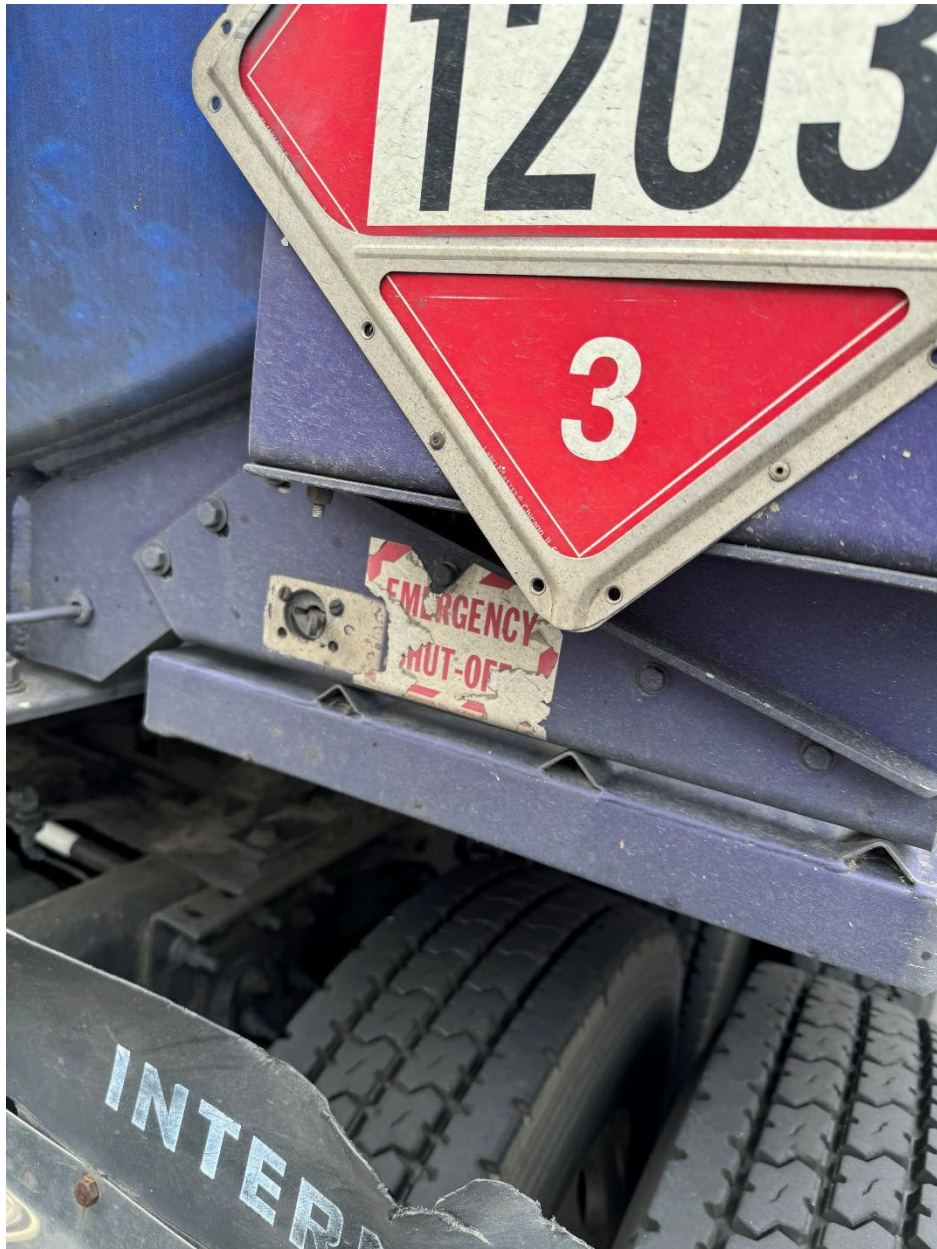
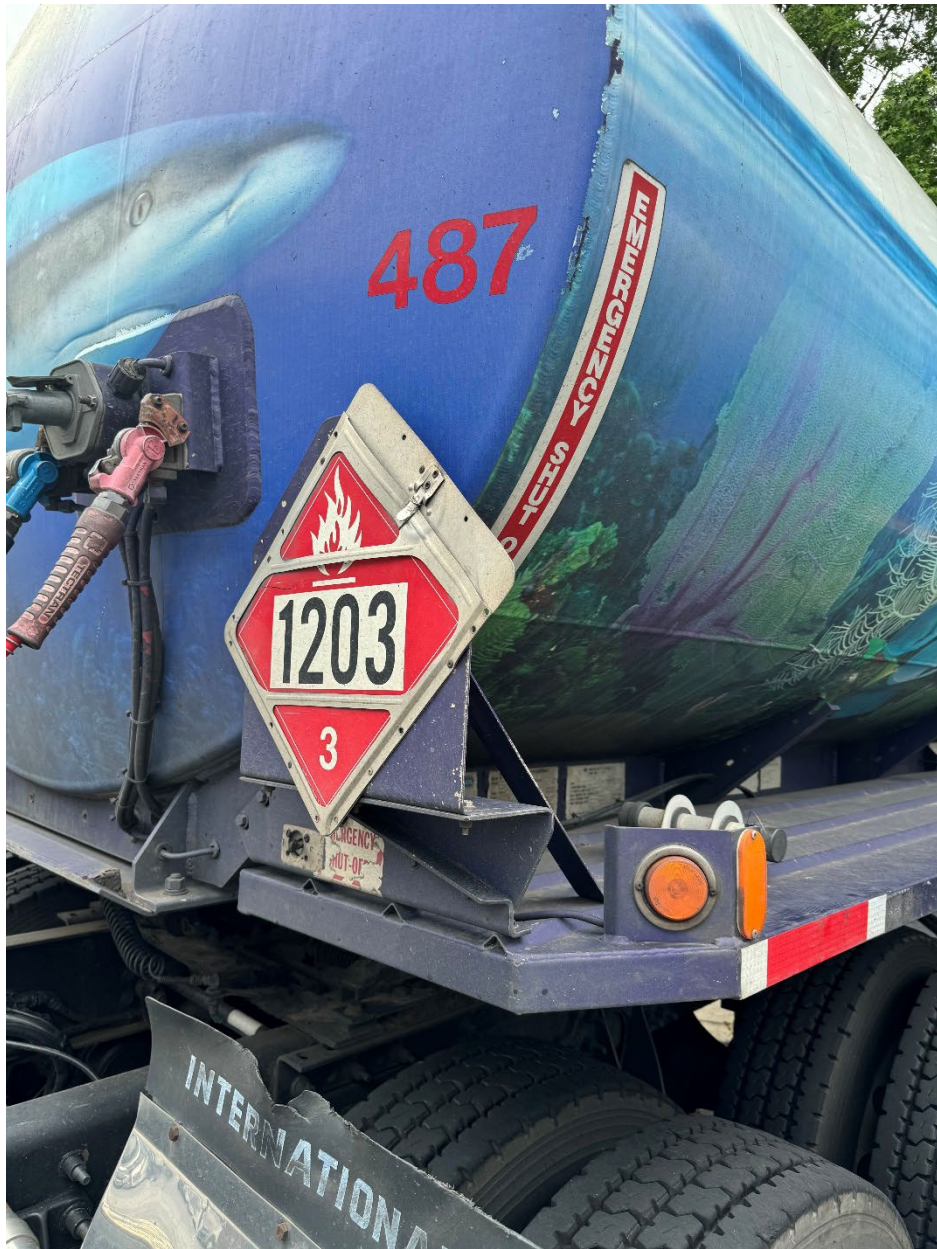
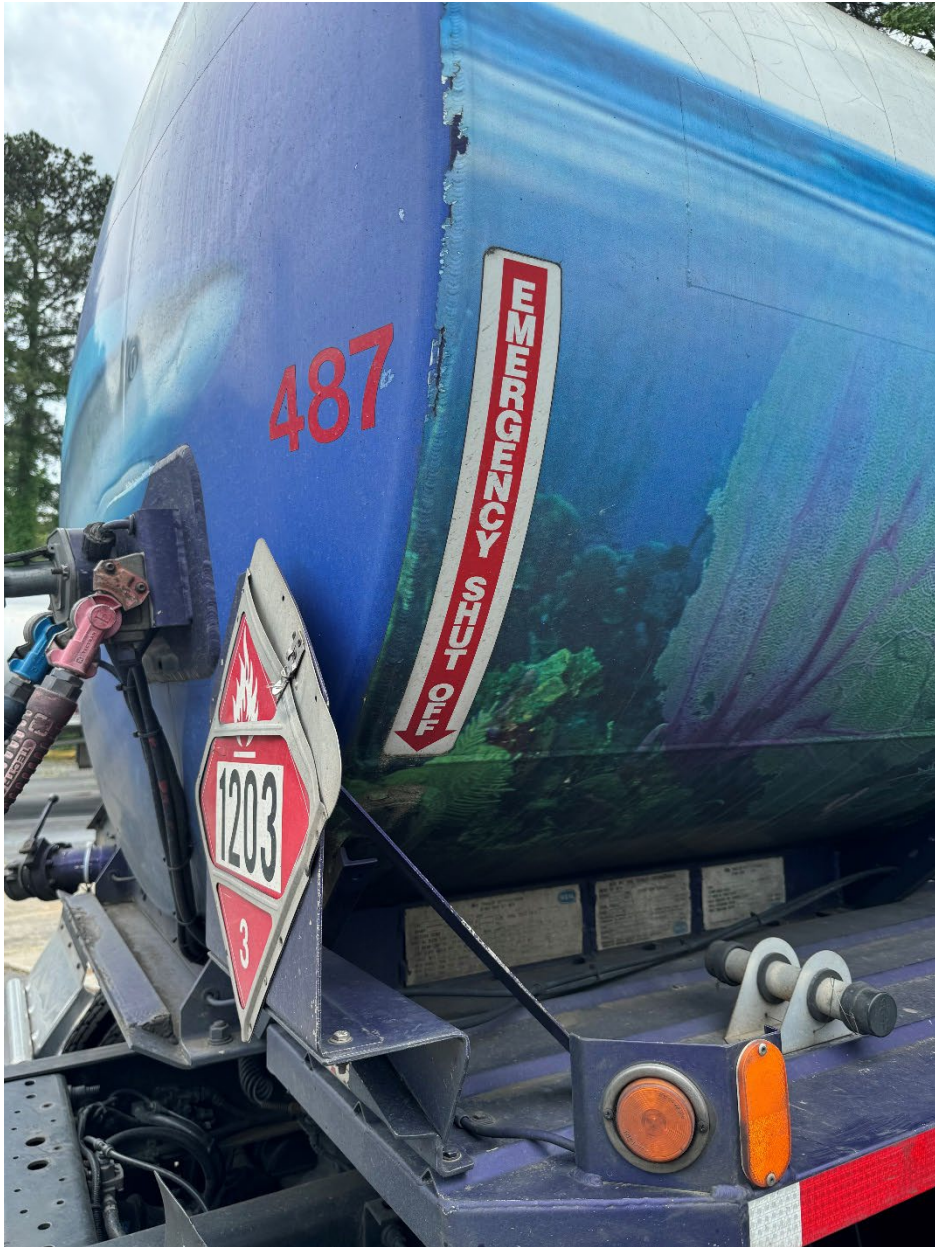
Usher Transport Inc. is seeking guidance on 172.328(d). We recently received a violation for failing to mark a manual remote shut-off device as required. The remote shut-off device was marked in two separate locations. One of the markings was located directly beside the shut-off. That marking was damaged therefore we received a violation. The secondary marking was in perfect condition and was located immediately adjacent to the means of closure. I have attached photographs for your review. I have also attached a PHMSA letter of interpretation that is an exact representation of our situation. The only difference is the location of our placard holder, which we feel solidifies the location of our emergency shut-off marking. If we elected to put the shut-off marking on the bulkhead it would have been located more towards the center line of the tank and therefore the distance would have been greater. Therefore, we placed the marking in the best location which we believe meets the interpretation. The state is claiming that our secondary marking does not meet regulation due to the arrow not pointing at the direct means of closure. Does our secondary marking meet regulations?

See Photo's below:

The HMR do not define the term “adjacent,” but a common dictionary definition of the term “adjacent” means to be nearby or immediately preceding or following. Based on the photographs you provided, it is the opinion of this Office that the secondary “emergency shutoff” marking located on the right rear side of the cargo tank does not meet the intent of § 172.328(d) because the marking is not in “an area immediately *adjacent (emphasis added)* to the means of closure.” Moreover, the secondary marking has an arrow pointing vertically downward towards a section of the CTMV on the back side of the framing on which the rear placard is displayed that does

not accurately point towards the means of closure of the shutoff device, which is located at the rear of the CTMV below the placard. Please note that the position where the damaged primary marking is located would meet the intent of § 172.328(d).
