# Inspection Bulletin

North American Standard Inspection Program

## 2018-02 – Motorcoach Monocoque Frame/ Suspension Inspections

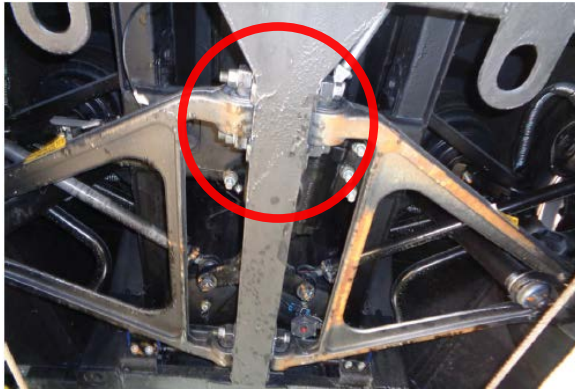
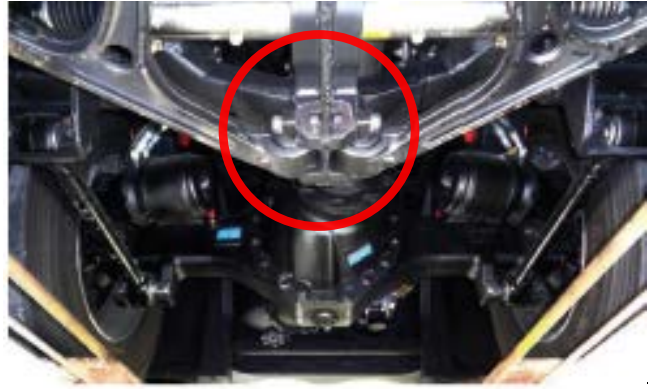
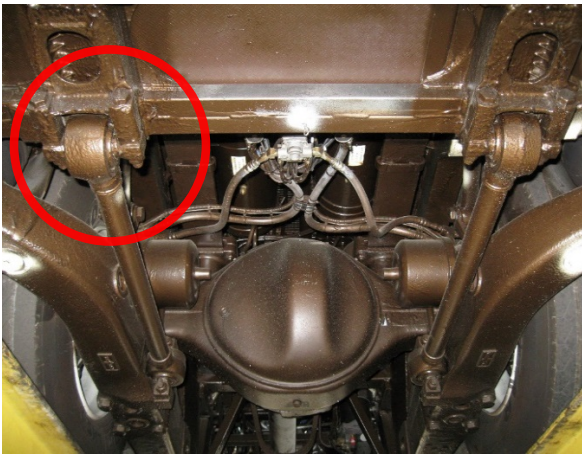
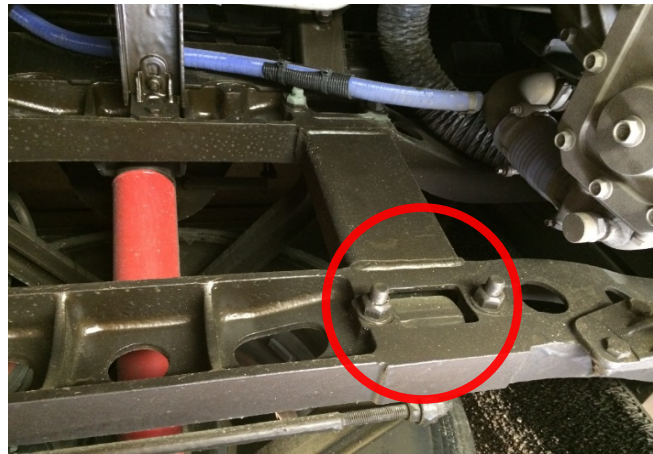
Below are examples of motorcoach monocoque frame and axle support areas that may be seen during inspections.

- 1) Axle mounting torque rods and/or radius rods are normally mounted to heavy structures incorporated into the main coach integral structure on one end, while the other end is secured to an axle. These arms may be attached by single or double bolts securing a retaining plate which maintain pressure on a rubber bushing. Some torque rods are attached with two bolts on a shaft through a rubber bushing much like a truck uses upper torque arms on tandem axles.
- 2) Motorcoaches with bent, broken or detached torque arms, or radius rod arms, that have not been properly maintained should be declared out of service. Motorcoach structures near these attaching points should be inspected within a radius of approximately 18 inches. Any tubing or structure showing separation or cracking on more than 2 sides of a tube should be noted and placed out of service.
