Inspection Bulletin

North American Standard Inspection Program

2022-04 – Passenger Carrier Vehicle Emergency Exit Inspection

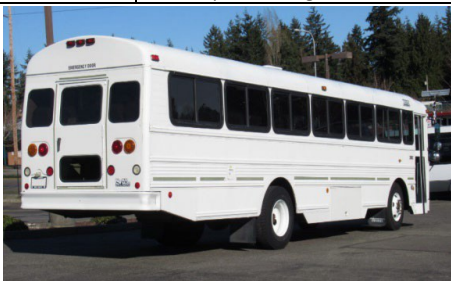
A commercial bus certifying under the PCVI Method Two Option A.

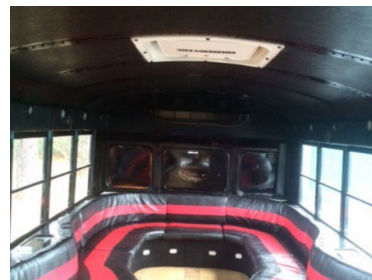
This converted school bus no longer meets Method Two Option A due to the removal of the rear exit door. A roof hatch has been added to comply with Method One.

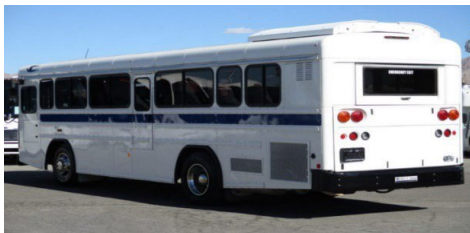
A commercial bus certifying under the PCVI Method Two Option B.

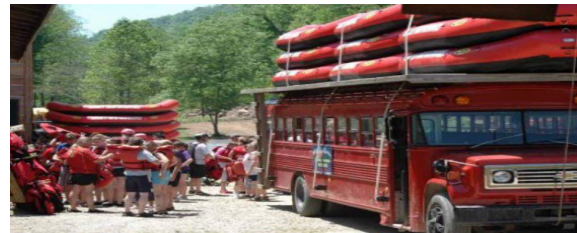
Providing transportation to adults will reduce the manufacturer's pupil seating capacity from three to two per seating surface. This bus does not require a roof hatch if the seating capacity is under 63 for Option A or under 75 for Option B.

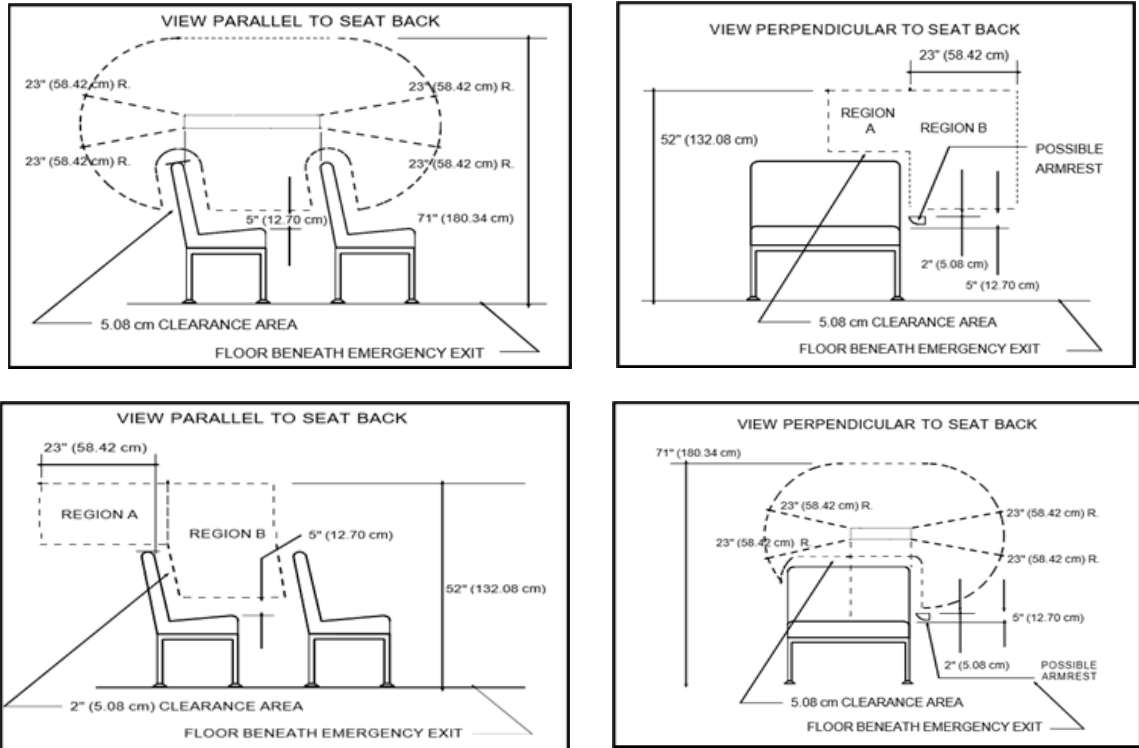
2. **Emergency exit release mechanism.** Each emergency exit must be released by operating one or two manual mechanisms located above the seat or arm rest located within that exit space, whichever is higher. The areas are outlined in the diagrams on the next page.

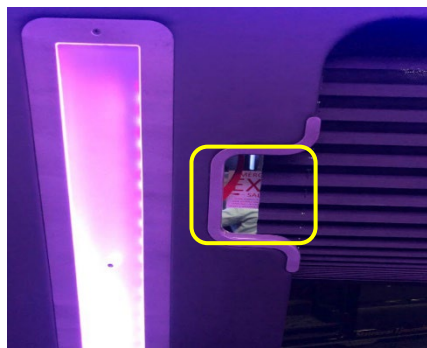
Custom panel cut away to allow access for the release mechanism.

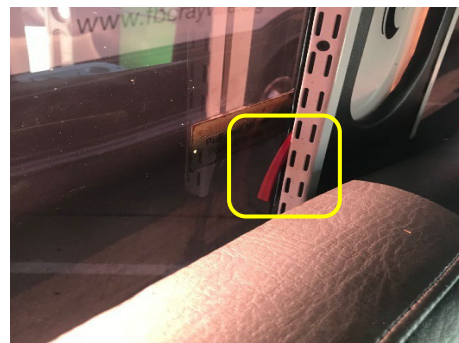
If the modifier fails to redesign the emergency exit to relocate the release mechanism(s) to the specified region(s) and the exit cannot be opened during the inspection process without the use of a tool, the mechanism is considered blocked, and an out-of-service condition is present for “required/marked emergency exit obstructed.” If the exit is operative (without the use of a tool) but the release handle is not located within the required area, a violation is present. (393.62(a)-(571.217 S5.3.1))

Custom panel and seat back blocking the release mechanism, making the exit inoperative.

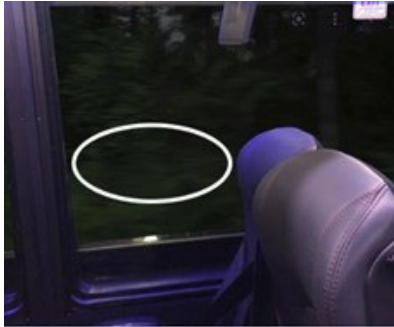
TV monitor and high back seat dividing the emergency exit space yet allowing passage through the exit.

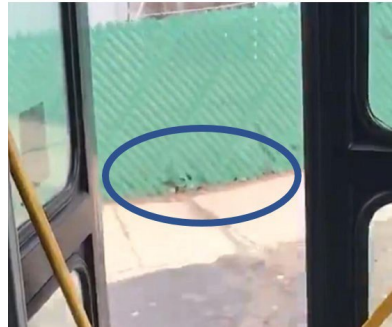
Only one side of double door opens when release is activated. The one door opening allows adequate passage of the ellipsoid through the exit.

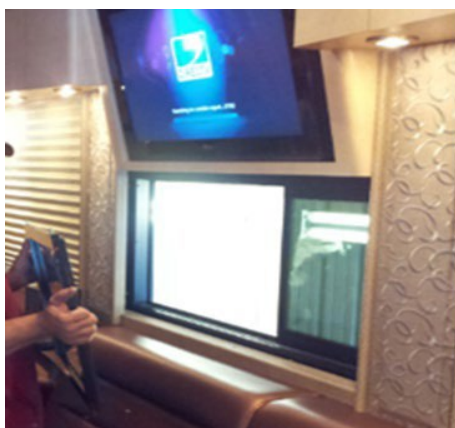
Exit designed to press down pins and lift window out of track. TV and panels installed to allow access and removal as designed.

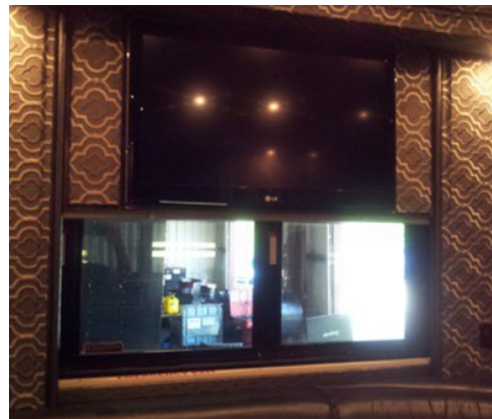
- 4. Unobstructed Access.** If an interior customization or other obstruction hinders access to the marked and/or required emergency exit, an out-of-service condition is present for “required/marked emergency exit obstructed” (393.62(a)-(571.217 S5.2.2.1)). For buses less than 10,001 lbs. (4,536 kg), 393.62(a)-(571.217 S5.2.2.3).

TV installation and panels fail to leave access to pins or enough space for window to lift out of track. This exit will not open.

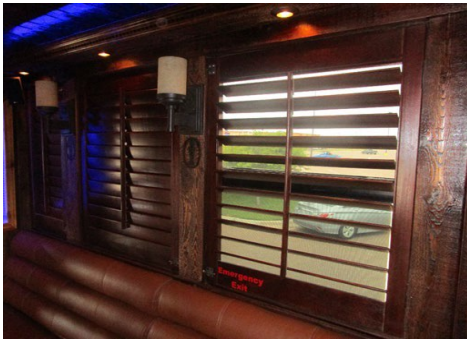
Exit obstructed by wooden plantation shutters.

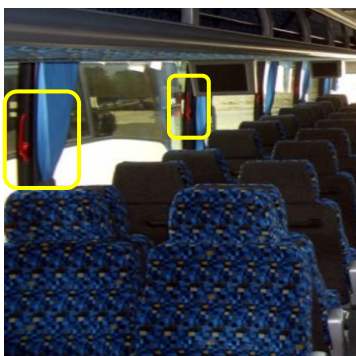
Typical fabric passenger window curtain

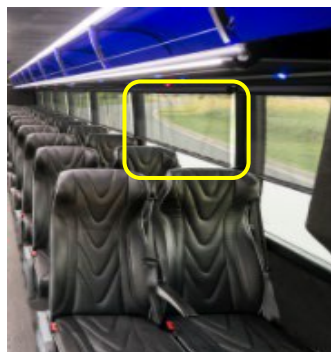
Fabric roll-up passenger window screen

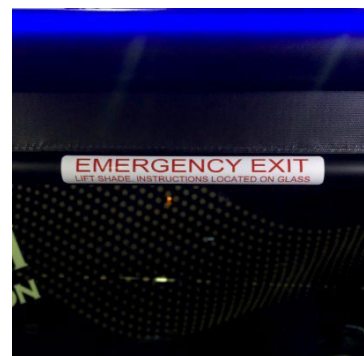
Emergency designation on black-out shade bar

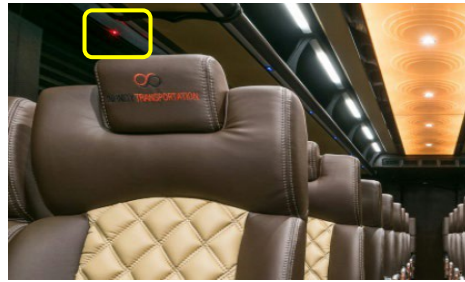
Some secondary manufacturers of limousines and custom coaches are placing red lights over emergency exit windows in lieu of the designation marking. This may be done in addition to the required labeling but does not meet the marking requirements in FMVSS/CMVSS 217.

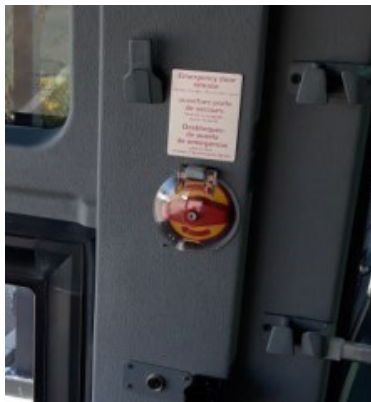
Door release valve inside a motorcoach at the entrance door.

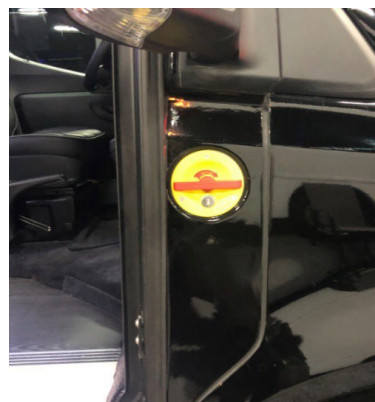
Exterior door release valve at the entrance door of a custom limousine.

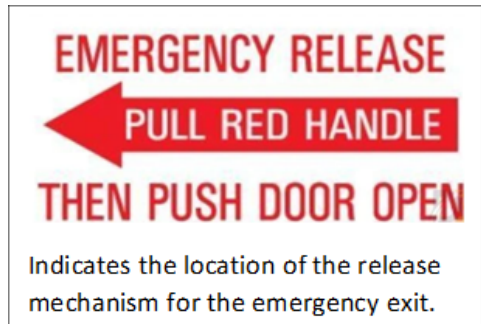
Example: “Emergency Exit Instructions Located Next to Seat Ahead”

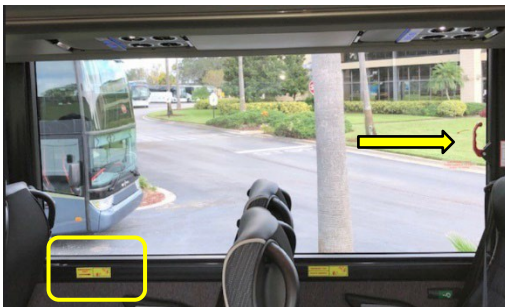
Two rows of seats occupy the exit space. There is only one release mechanism to open the exit located in the space to the right. A marking indicating the location of the release mechanism has been placed in the exit space of the seat to the left.

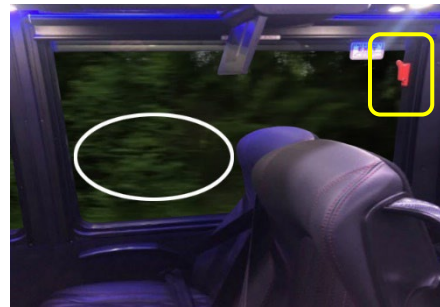
Two rows of seats occupy the exit space. There is only one release mechanism to open the exit located in the space to the right. A marking indicating the location of the release mechanism is missing in the exit space of the seat to the left.

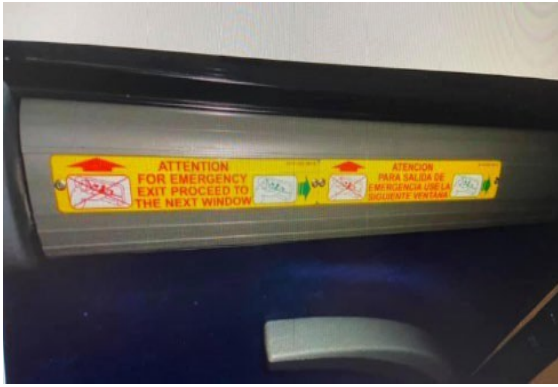
Pictograph and text clearly indicating this non-opening window is not an emergency exit and the location where the exit may be found.

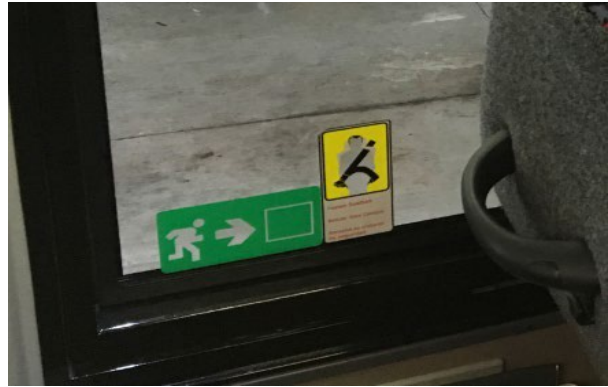
Green pictograph indicating an exit is located to the front of this occupant's space.

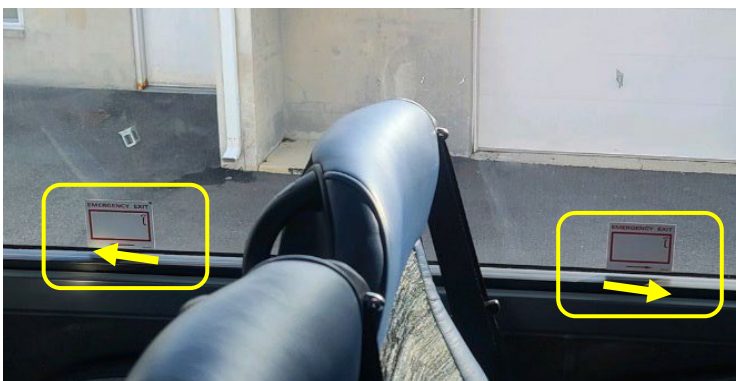
These markings, placed on a non-opening window, do not clearly differentiate between an actual emergency exit and where one can be located.

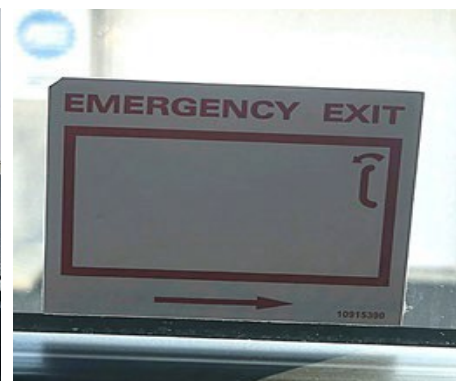
This same marking would be acceptable when found in the occupant space of an emergency window with a single release mechanism to the right.
